IMPORTACIONES GAMBOA S.A. (IMGASA)

Available For the First Time in Latin America Complete Rebuild / Repair of MAN Diesel & Turbo Diesel / Bunker C Fuel Injection Pump

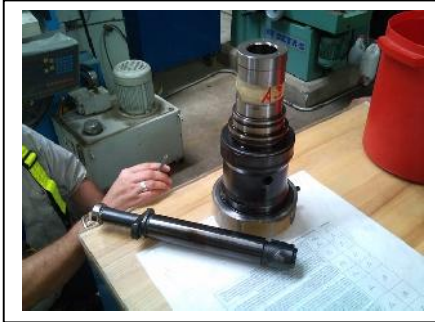
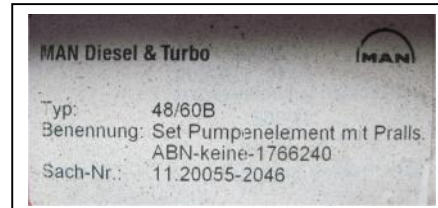
All repair work done in the USA with state of the art dedicated ID grinding machines; capable of deep dead hole ID grinding, using custom ant-rattle spindle, quill and grinding wheel. Plus a custom made hard chrome deep hole anode. Over one year in development.

Here is the before and after. Why buy new when a complete refurbishment makes your MAN Diesel fuel injection pump better than new at a fraction of the cost?

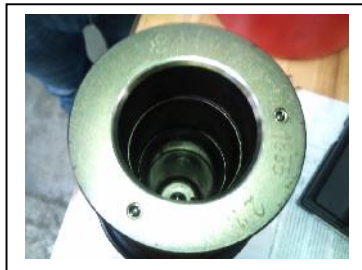
After running the pump for an extended period of time the bottom of the deep hole has the hard chrome worn away to bare metal. This causes the pump to leak and it is taken out of service. We deep ID grind the hole, hard chrome all the way to the bottom, then grind again to factory new chrome thickness.

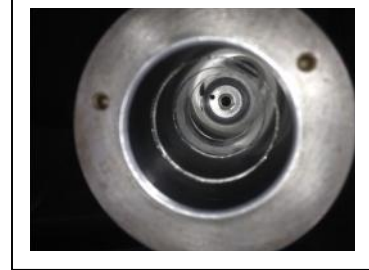
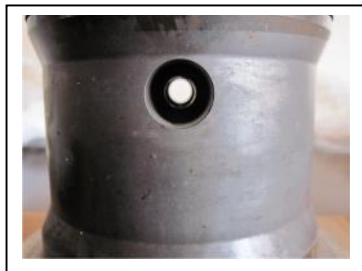
The exhaust ports over time become corroded and pose a risk that a loose flake of metal will break loose and cause damage as it travels with the flow of fuel. We smooth the rough points and flash chrome to prevent further corrosion.

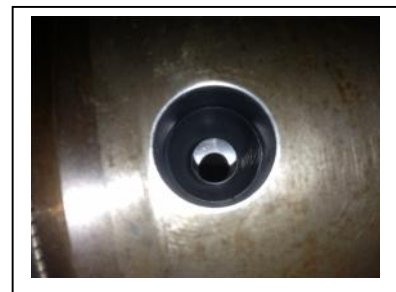
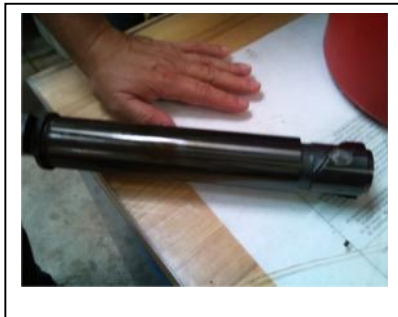
Corrosion damage to the plunger is normally at the bottom end. Also a hazard with loose metal and loss of pressure. The original part is not hard chromed. We grind and hard chrome so the tolerance between the plunger and barrel is like factory new.
